# OPERATION CROSSROADS

## BUREAU OF SHIPS INSTRUMENTATION GROUP

SECTION X

### Shock Measurements

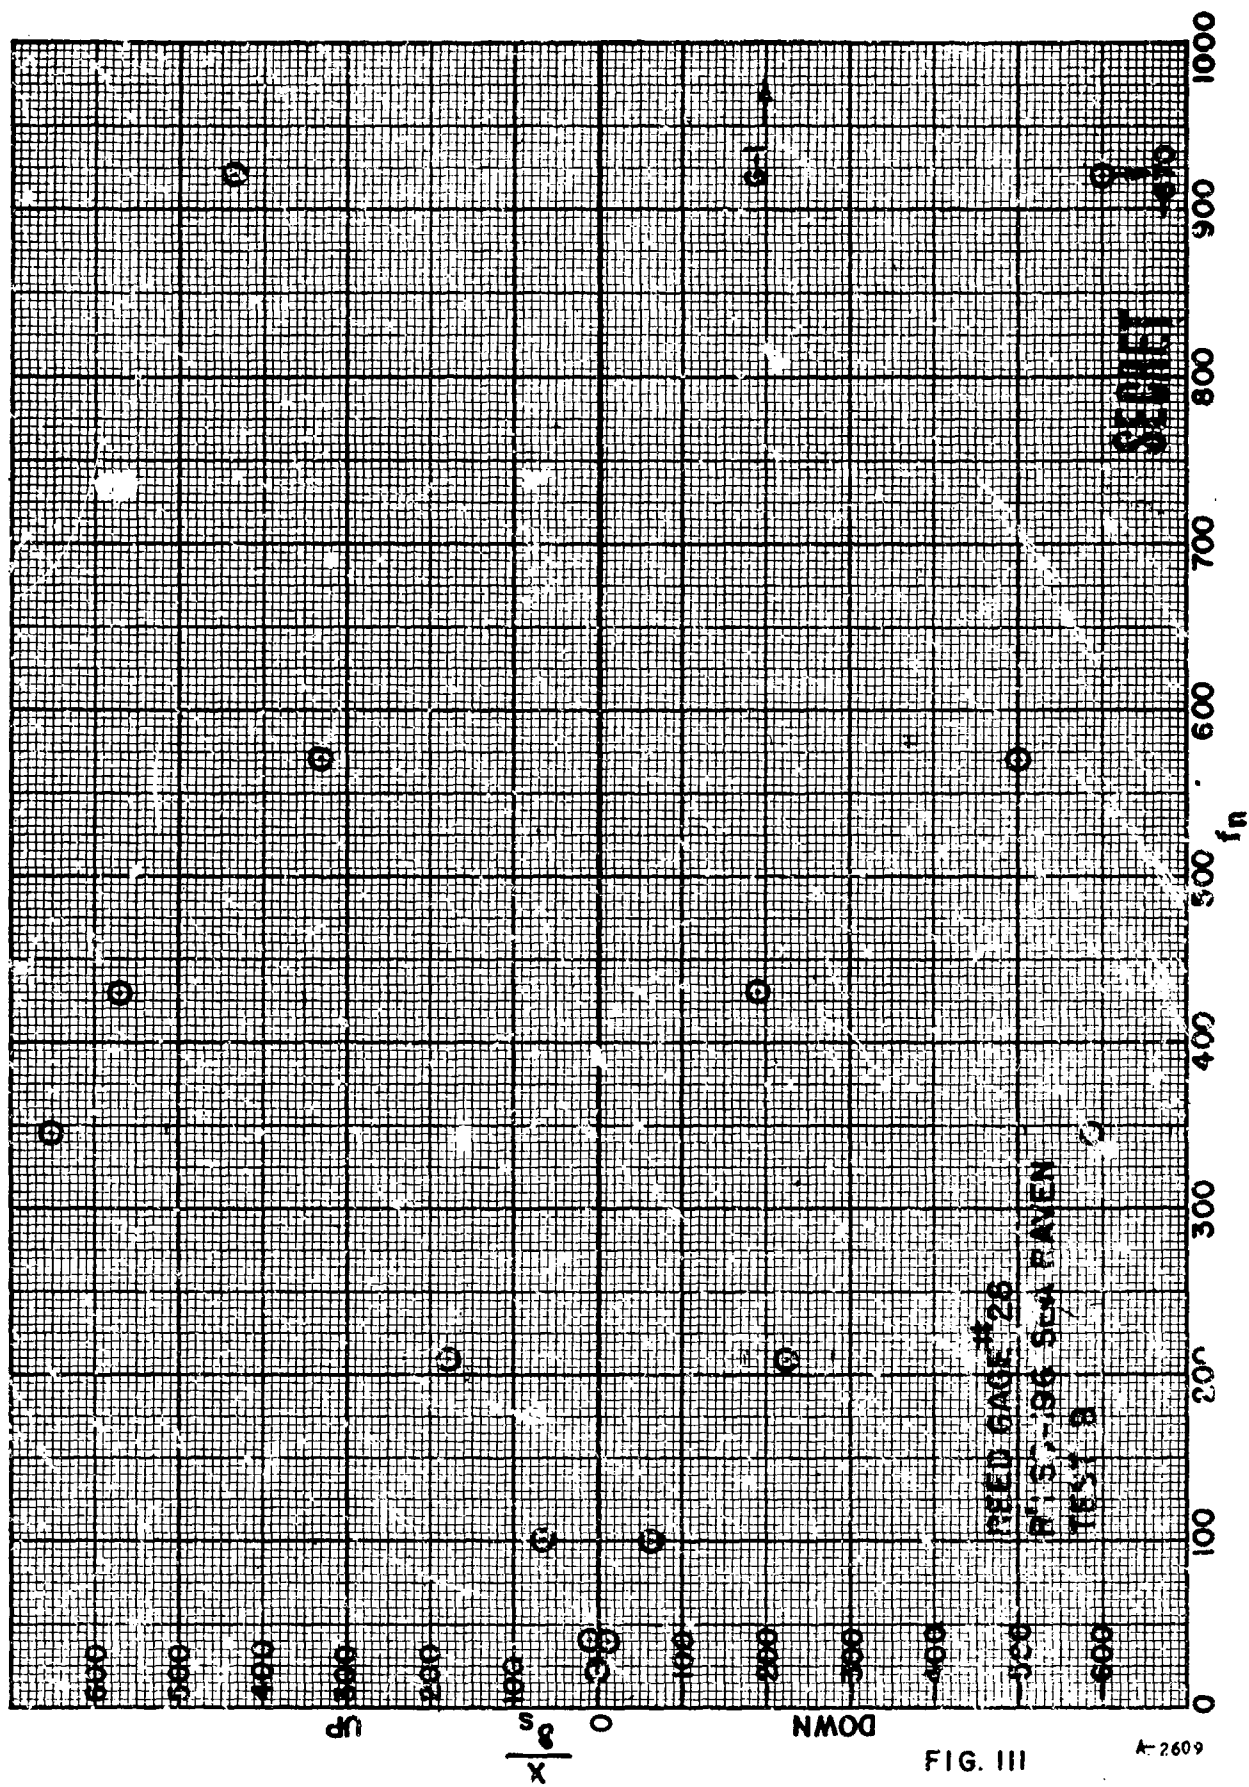
FIG. III

The submarine was submerged to 80 ft. keel depth. A few minor evidences of shock are reported by DSM. The gage locations probably recorded the maximum shock on this ship except for locations on the hull or hull frame numbers. The reed gage indicates a critical frequency of about 300 cps.

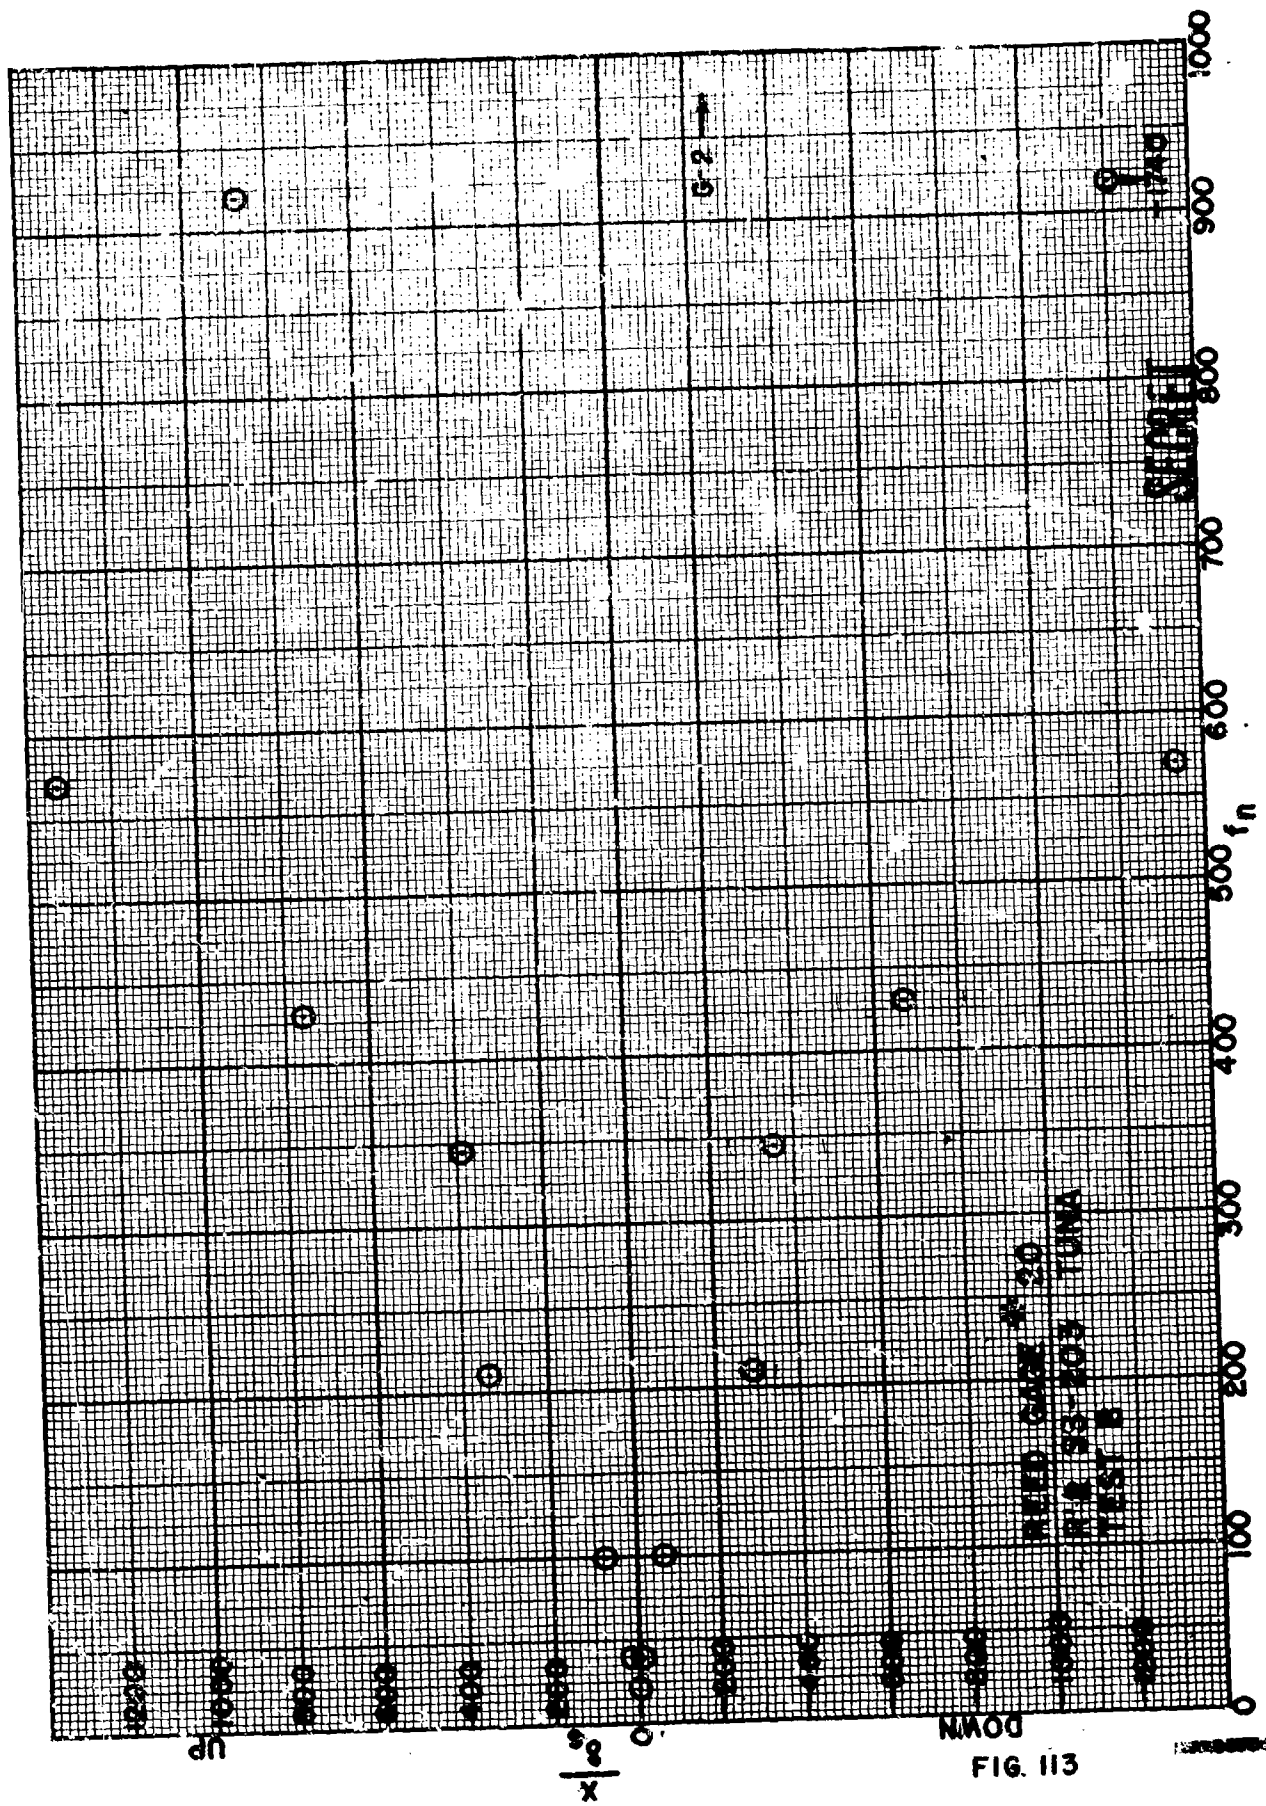
FIG. 113

Baker Range 5525 ft. Bearing 341°  
The submarine was submerged to 80 ft. keel depth. A few minor evidences of shock are reported by DSM. The gages probably recorded the maximum shock in the vessel due to their location. The reed gage indicates a critical frequency at 210 cps and possibly another at 600 cps.

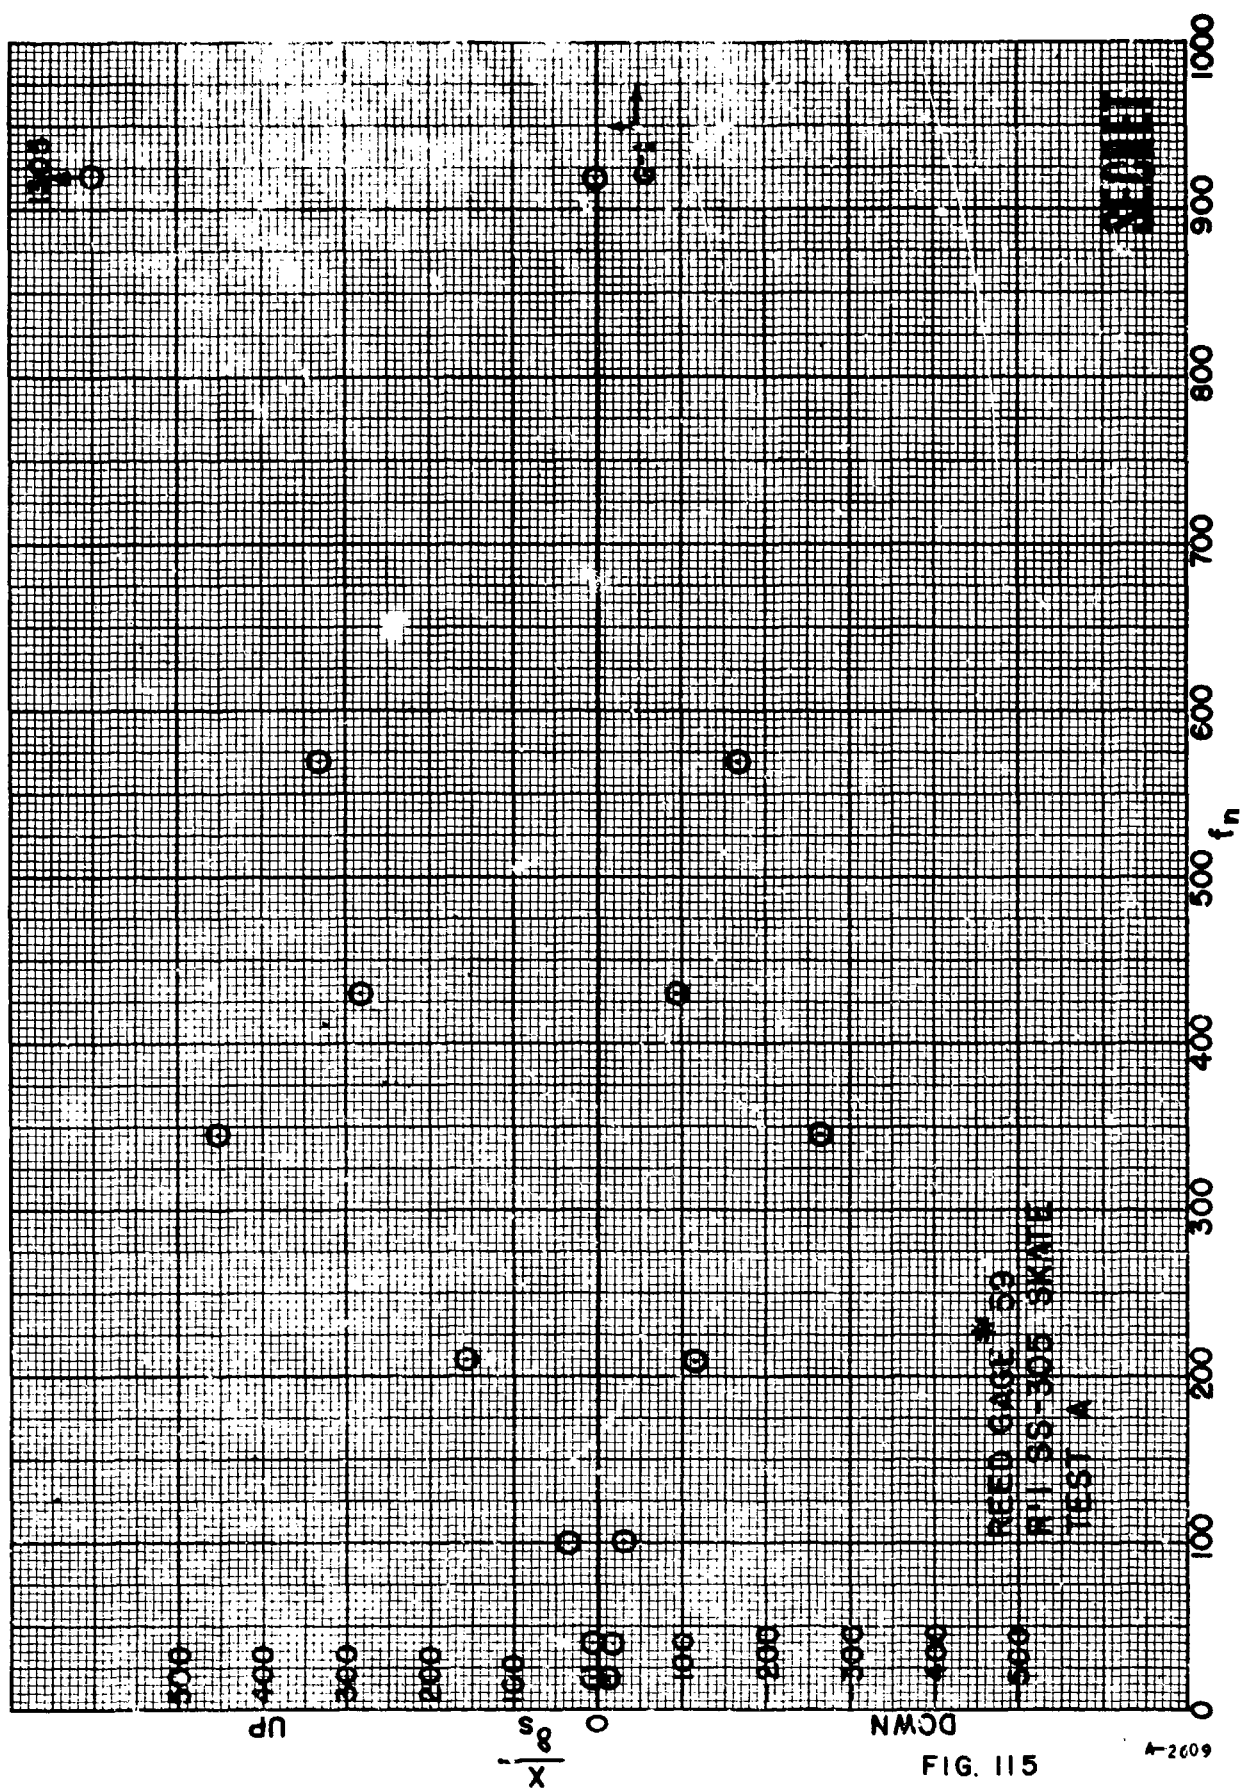
FIG. 115

DSM reports a few evidences of shock including 6 broken light bulbs in the after torpedo room and distorted torpedo tube cradles. The gages were not well placed for recording the maximum shock since they were slightly below the waterline at the port bow. The reed gage record indicates a peak response at 350 cps.

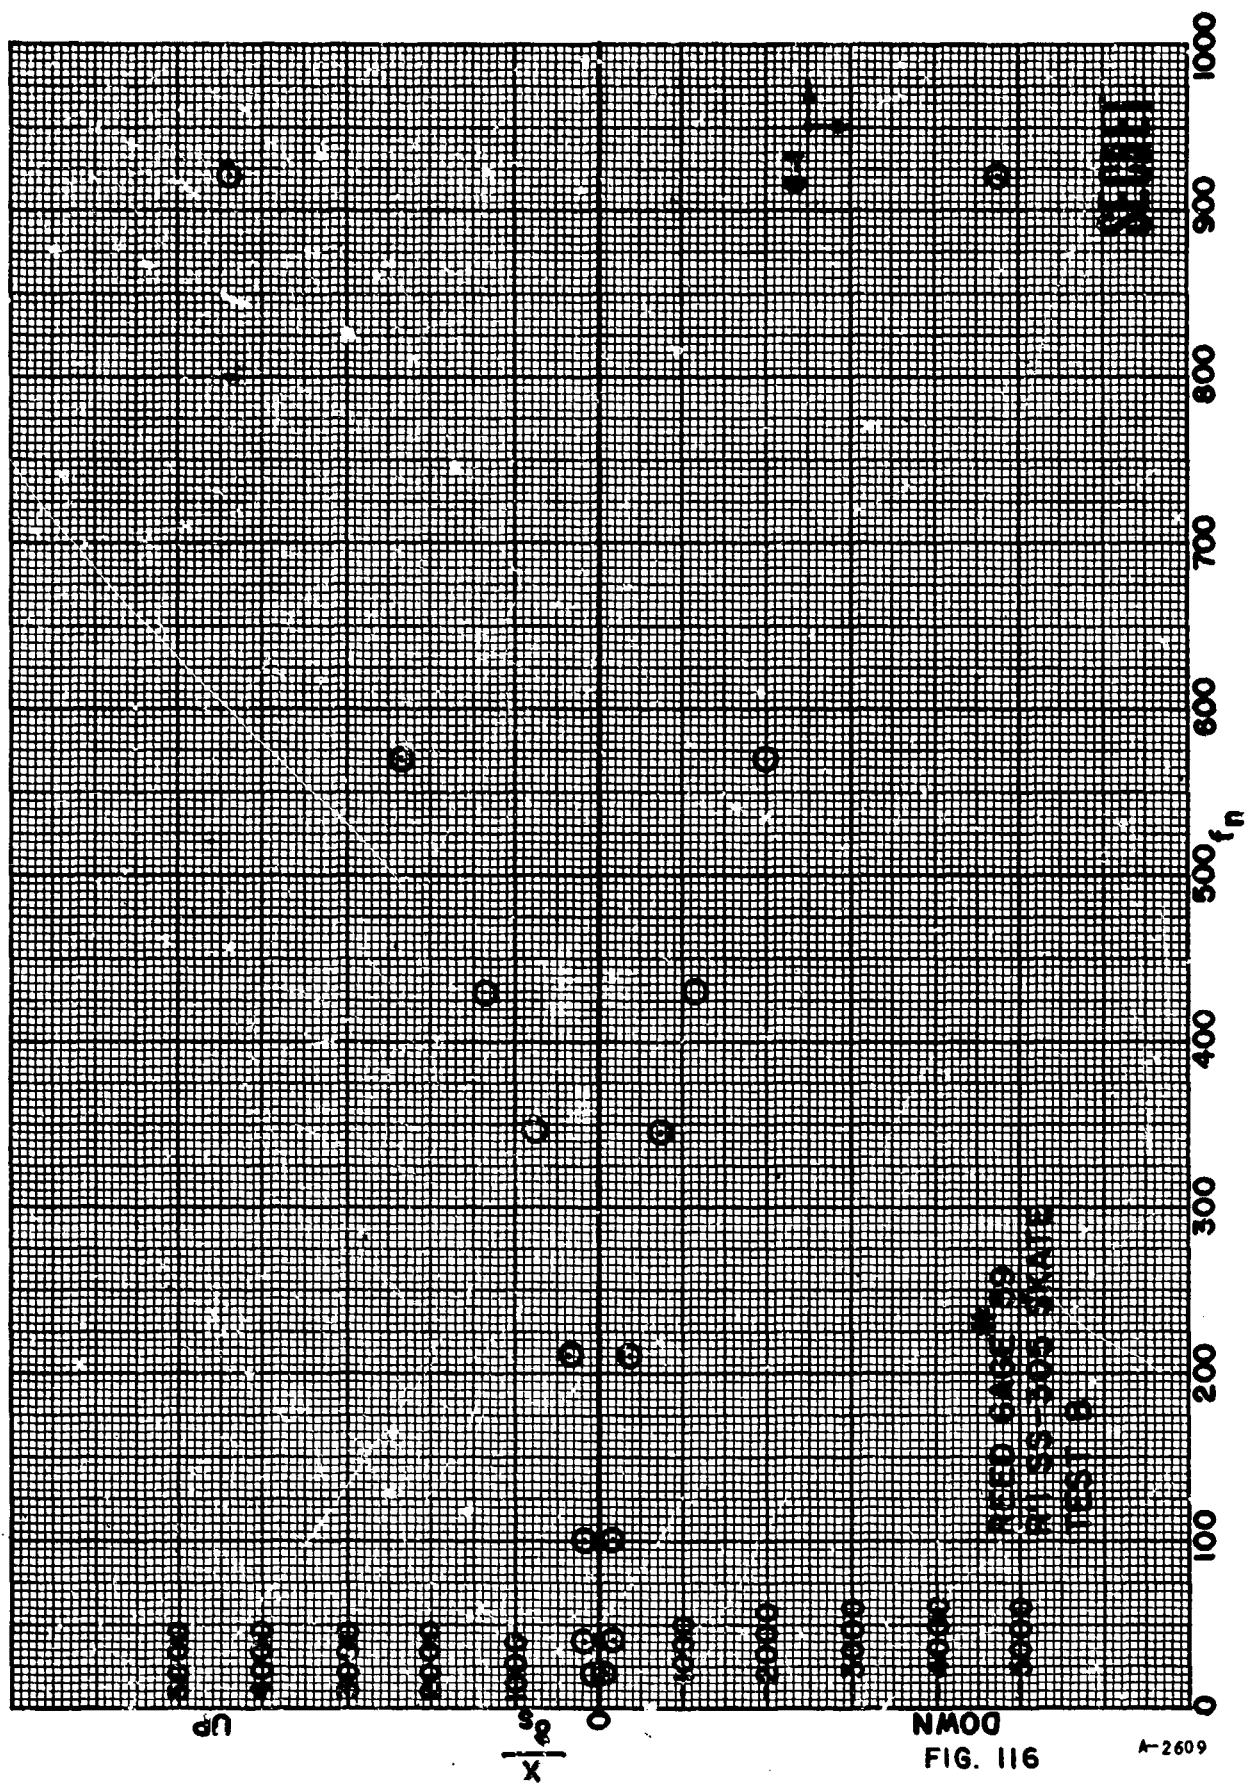
FIG. 116

The submarine was on the surface for this test. DSM reports shock damage to batteries, hard-rubber battery ventilation ducts, the master gyro, and auxiliary gyro compass. The shock damage was confined to these few items. The gages recorded the maximum shock in the submarine because of their position on the hull at a point closest to the bomb. They show far heavier shock than any other NRL gages because the other gages at this range or closer were shielded. While the peak acceleration was over 2500g, the time duration was very short. The reed gage indicates a duration of less than half a millisecond. This short duration, also indicated by the small size of all the putty gage indentations, in addition to the relatively shock proof construction of a submarine, apparently accounts for the small shock damage.

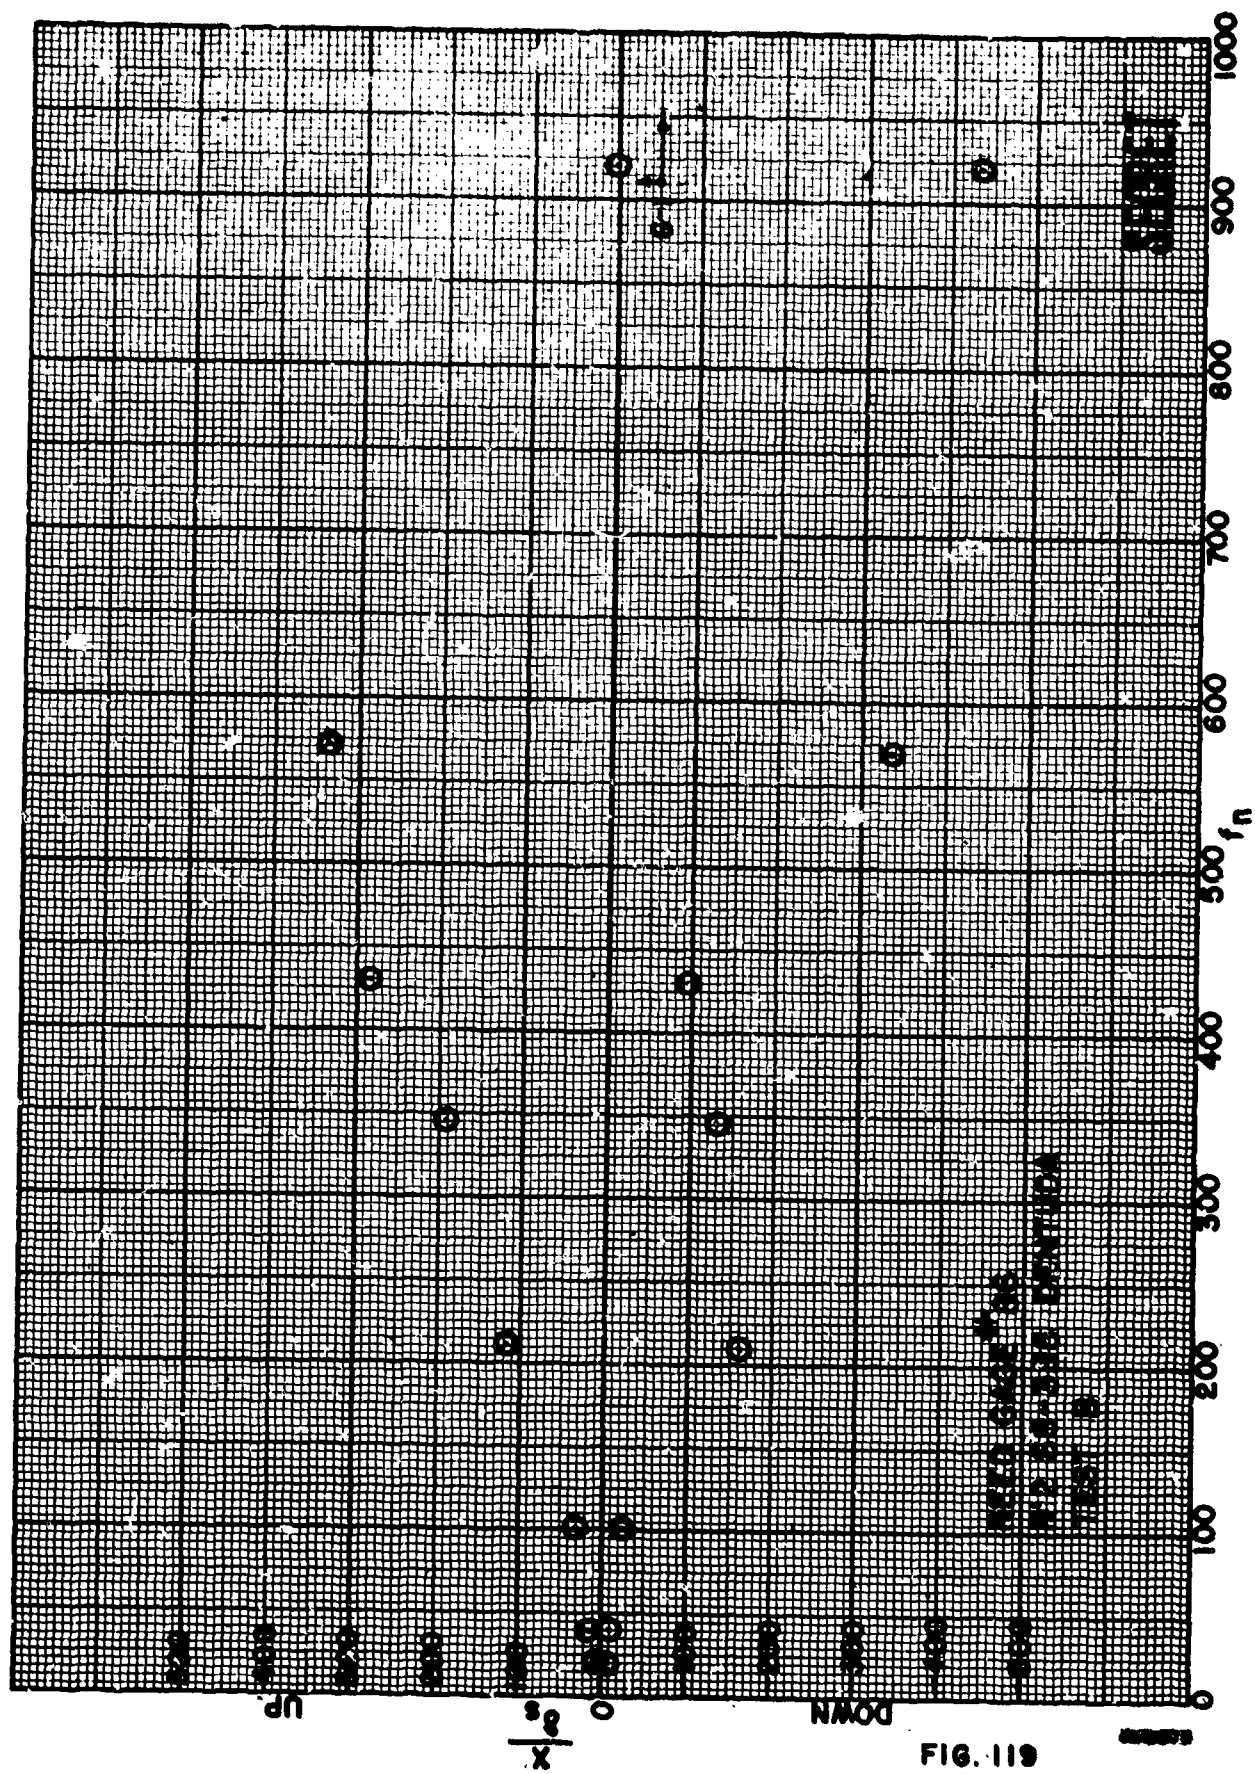
FIG. 119

The highest putiy gage readings are on gages on the hull frame. These gages are G2, G3, G8, G9, and G10. G1 on the portside hull was shielded and showed no shock. G13 on the shock mounted control cubicle did not record a shock while other internal positions indicated about half the peak acceleration of the shell gages. The R'1 readings are too small to indicate a critical frequency with any accuracy although a critical frequency of 210 cps is possible. R'1 was adjacent to G1 and was shielded from the direct shock.

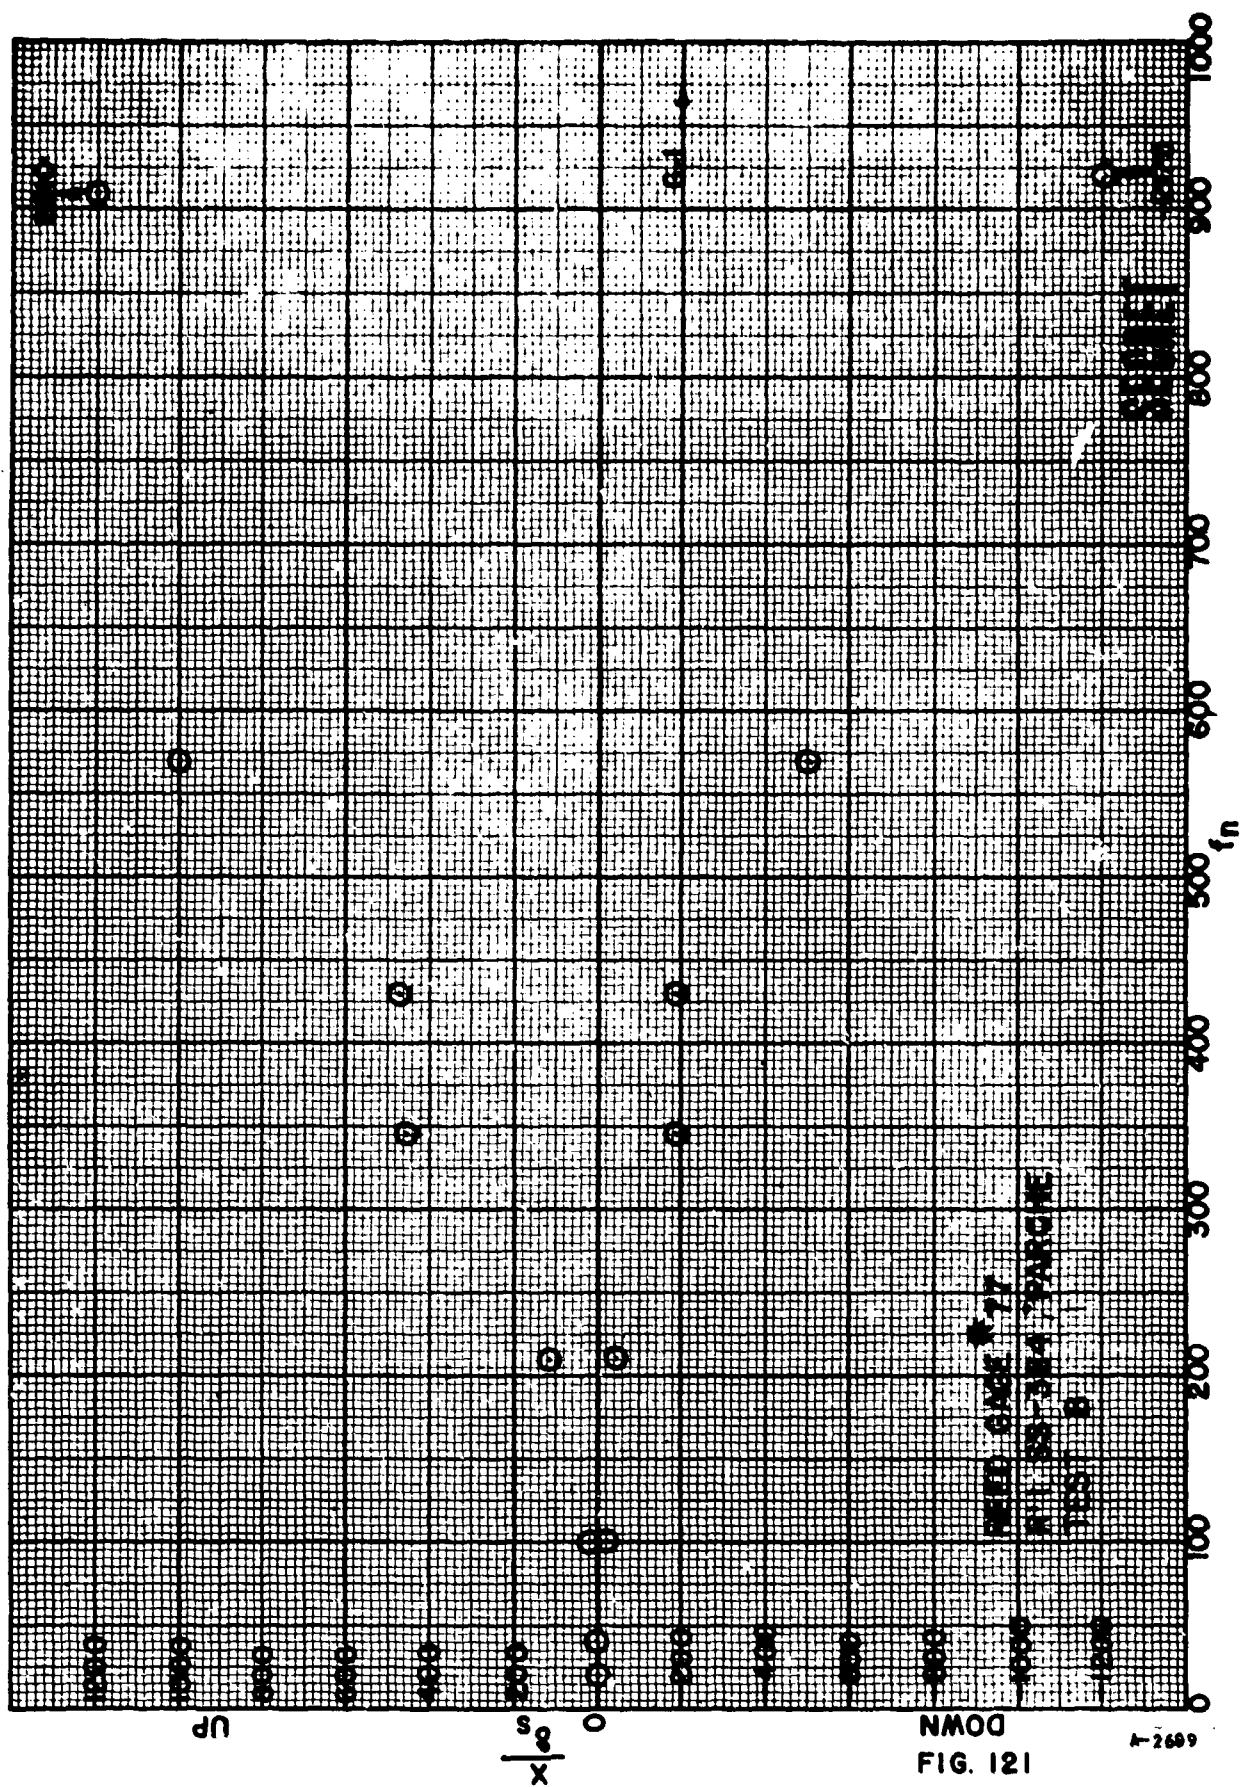
FIG. 121

This submarine was on the surface and received no shock damage, according to DSM. The peak acceleration indicated by the putty gage is 200g. The reed gage indicates a duration of acceleration of less than a millisecond. The duration apparently was too short for the putty gage to record the full peak acceleration.

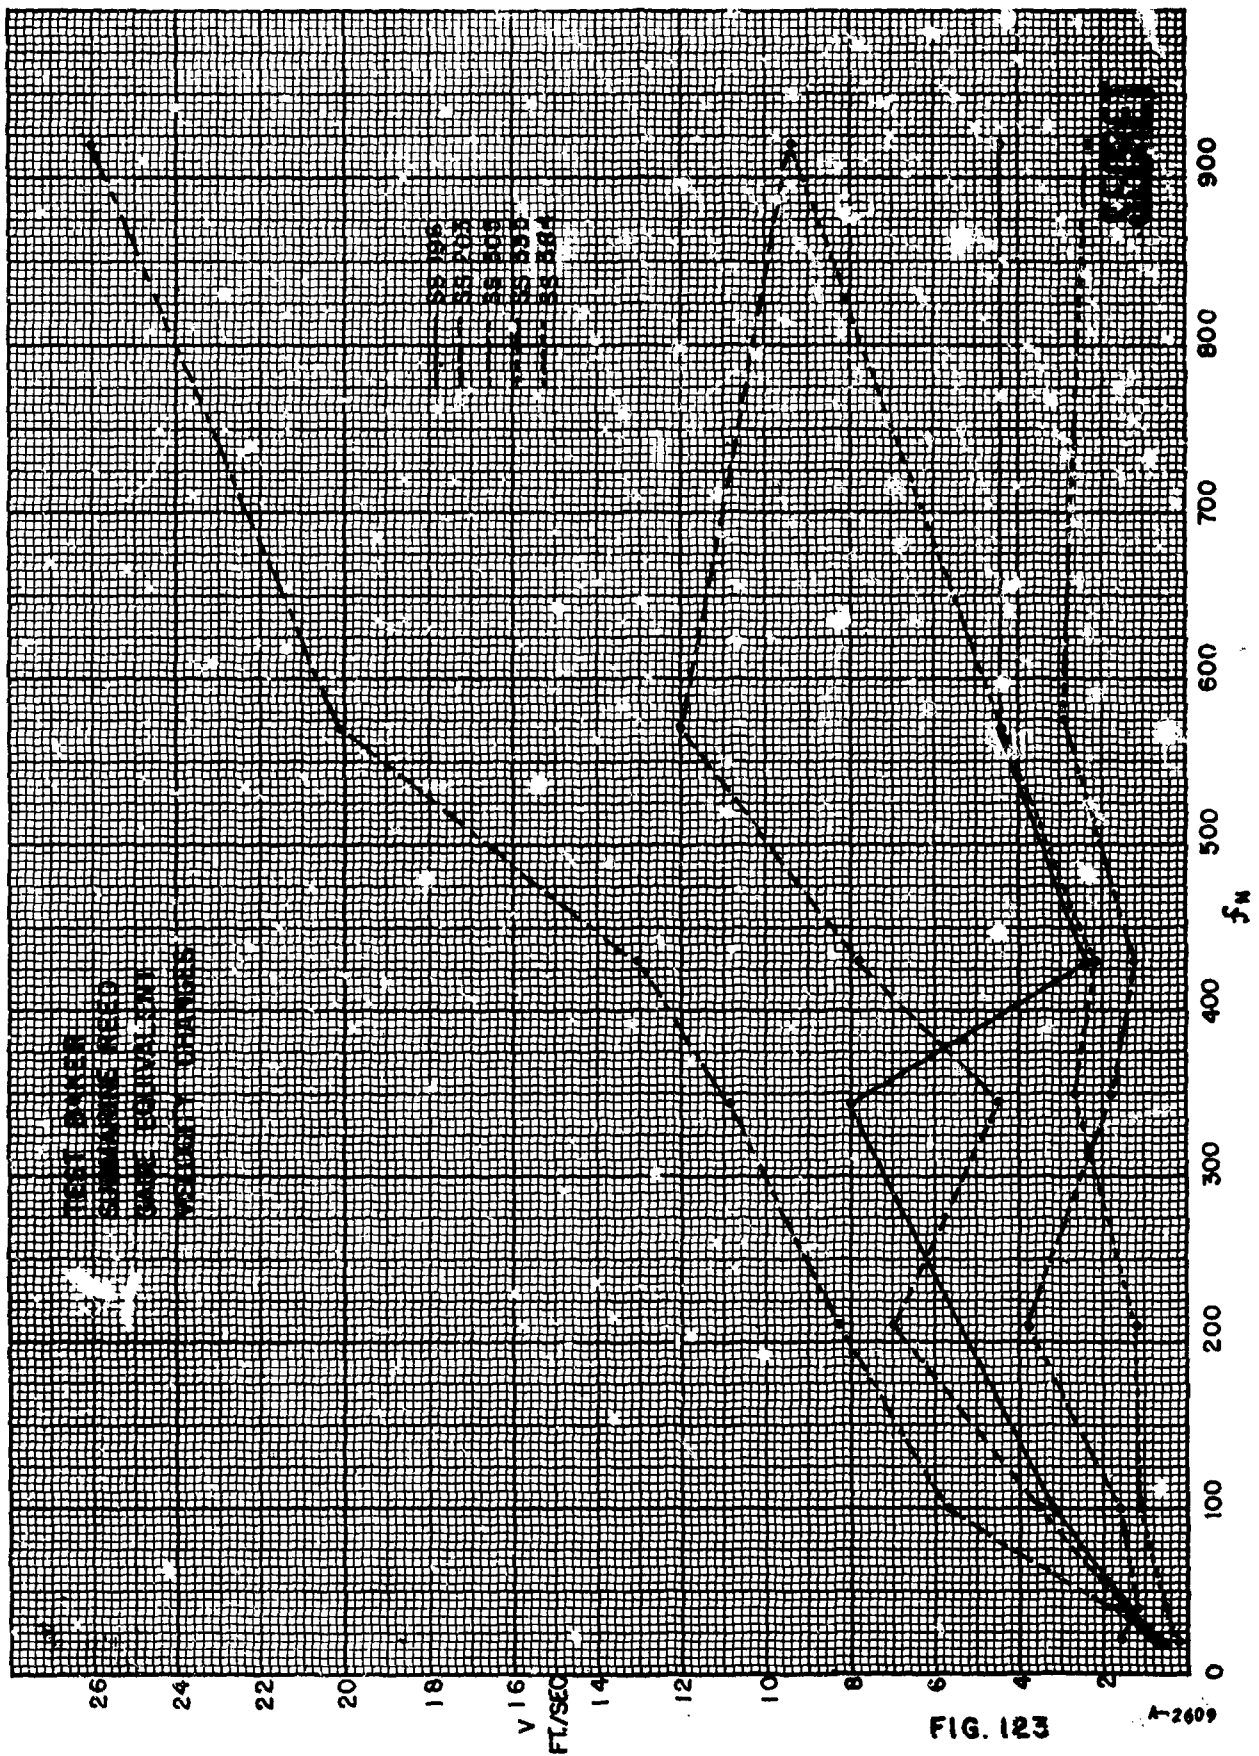
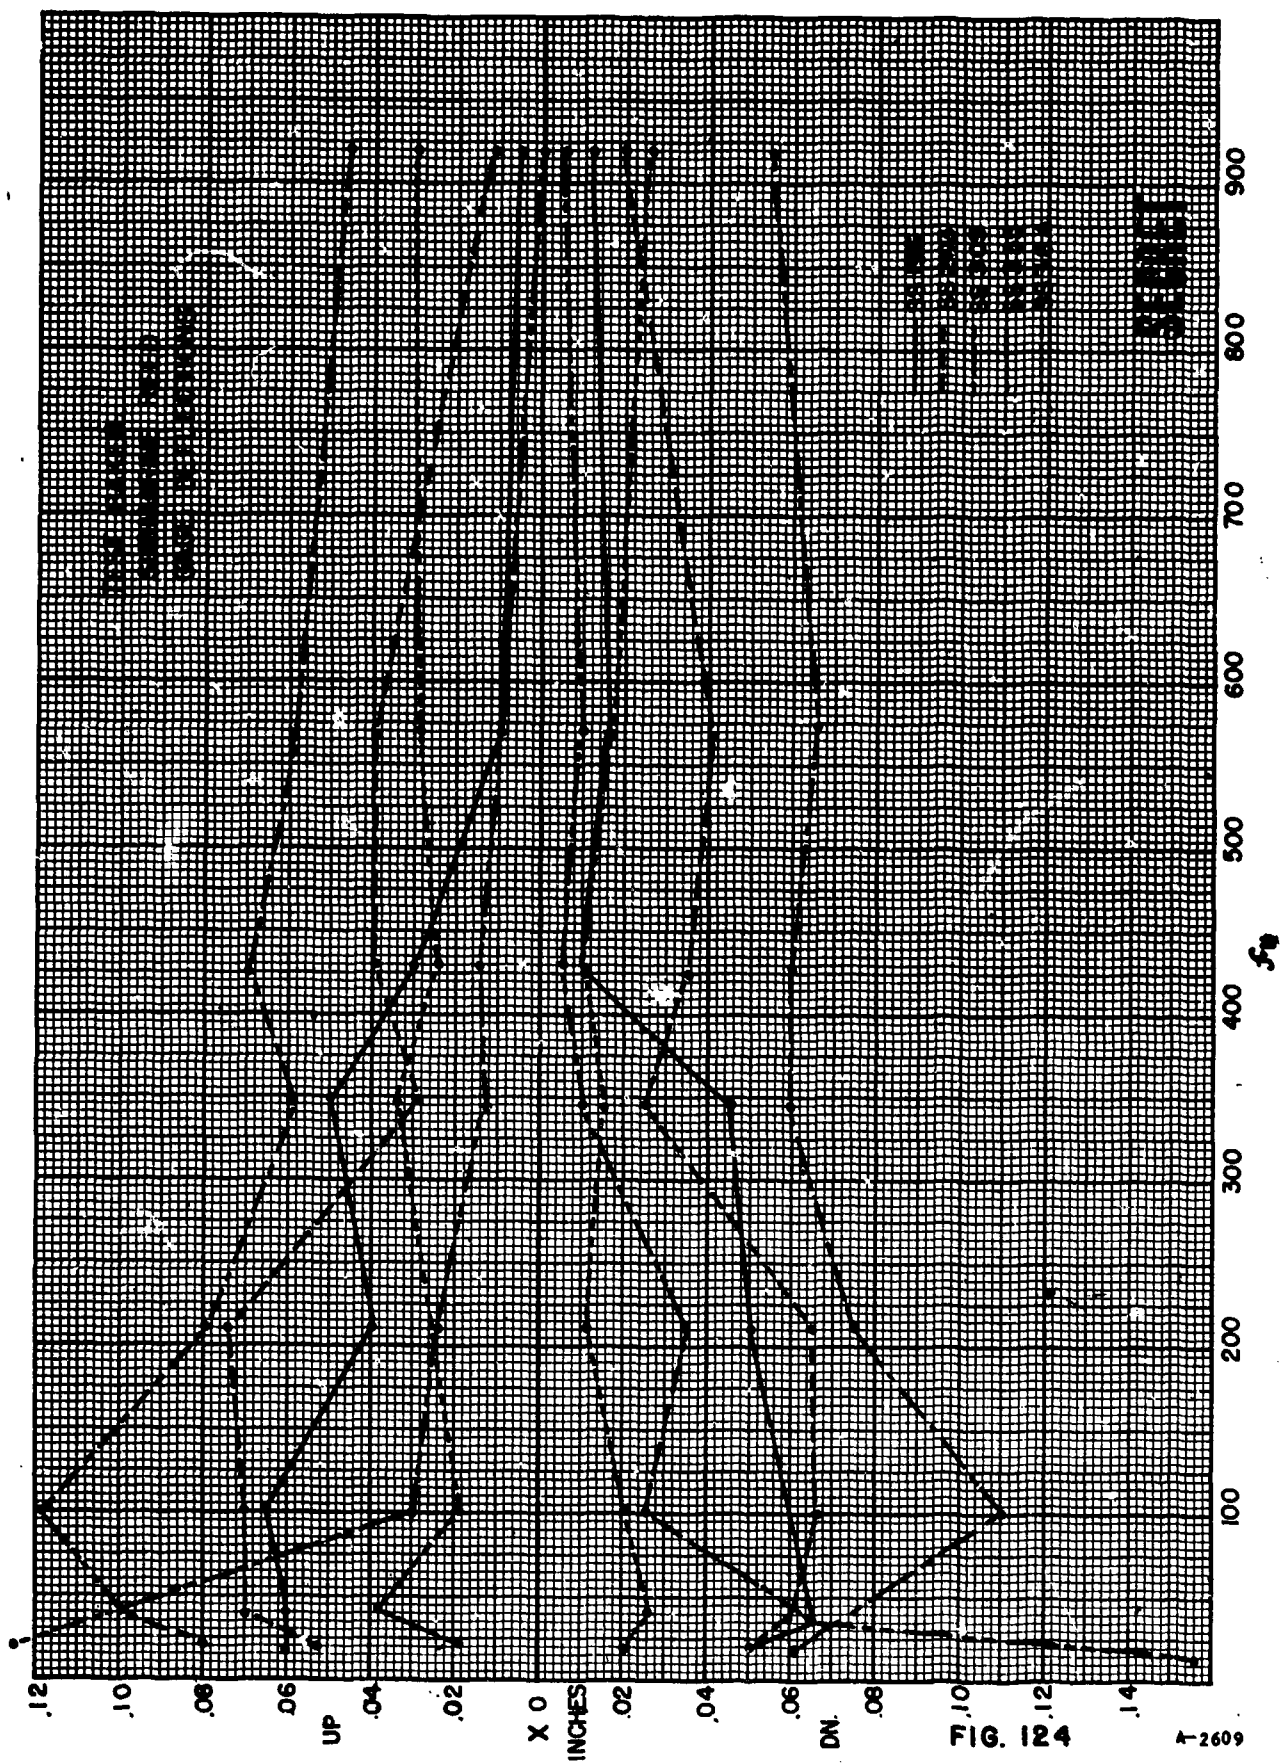
FIG. 124

A plot of reed deflection vs. natural frequency is shown in figure 124. The equivalent simple shock for the SS305 seems to be an instantaneously completed displacement of about .07 inches; the SS384 equivalent shock is an instantaneous displacement of .015 inches. Both of these submarines were on the surface. The submerged submarines do not have quite as simple an equivalent shock since the amplitude falls with increasing frequency though not fast enough for a sudden velocity.

change shock. It should be remembered that these equivalent shocks are simply those which will produce approximately the same reed deflections; they are not necessarily the same as the actual shocks.

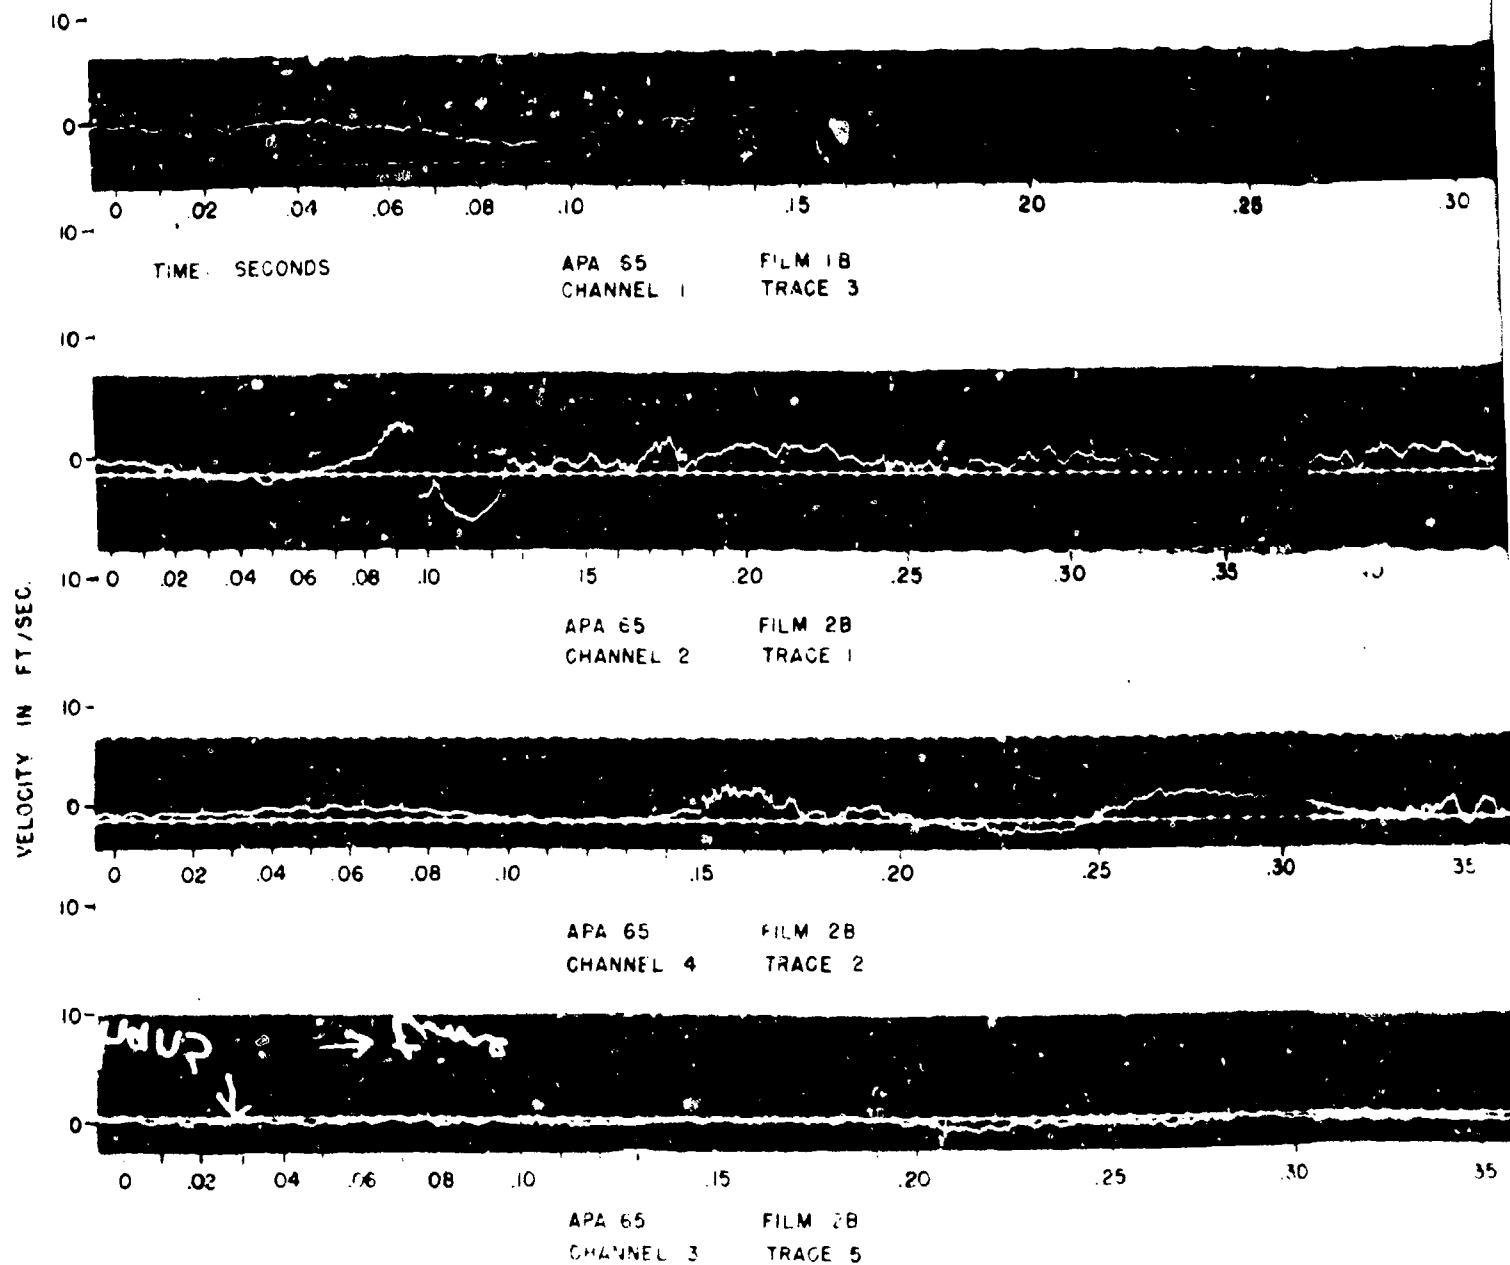
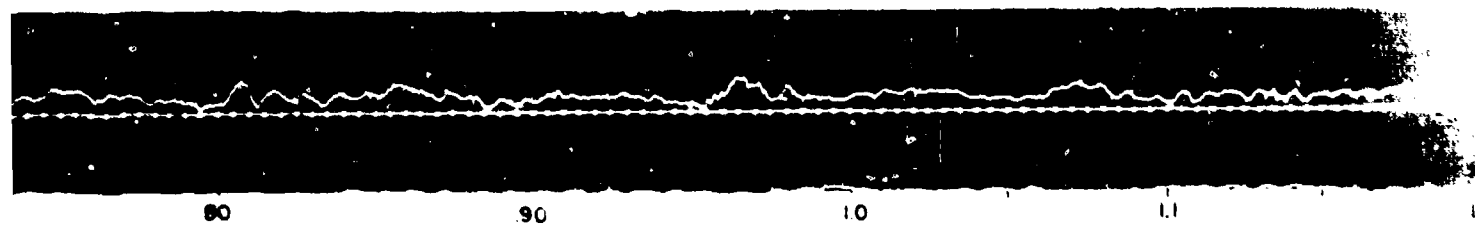
FIG. 128

1.40 inches from the last bottoming. Thus the only large velocity changes due to the initial shock front seem to be the initial acceleration and deceleration. Following these, the velocity changes from 4.5 ft/sec. to zero in an interval of over 150 milliseconds. The first triangular pulse of the V12 record has a duration of 2 milliseconds and a peak value of 10 ft/sec. The displacement caused by this pulse is therefore .12 inch. A transient vibration at high frequency follows this pulse. The similarity of the V12 record and the start of the V8 record with the V10 and V6 records on the APA64 shows reasonable correlation.

The putty gage G1 adjacent to V4 recorded 700g, which was the second largest putty gage reading of the Baker test. It is noteworthy that this was one of the few hull putty gages at a proper location to record peak hull acceleration. Accelerations on machinery foundations were higher than usual, being 200-250g.
